# Manhole Inspection Summary

Manhole # S29YY\_004MH

Insp Date: **9/10/08 12:11 PM**

**Location** Address: **GILMAN TERR**

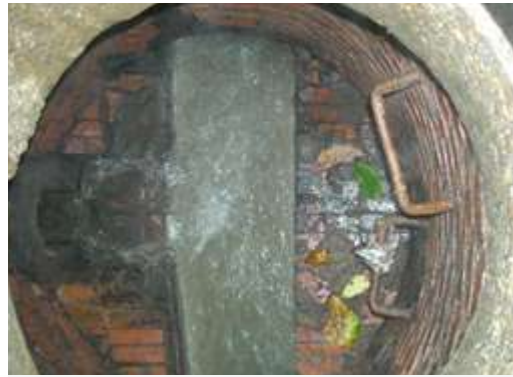
Top View

Corroded steps. Evidence of surcharge - Bench debris.

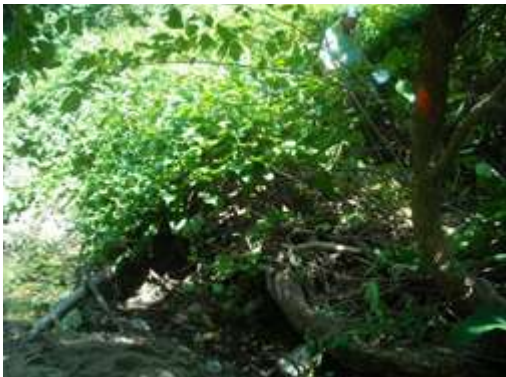
MISC.

SUBJECT TO INUNDATION; LOCATED 4-5 FEET ABOVE CREEK, IN FLOOD PLANE AREA.

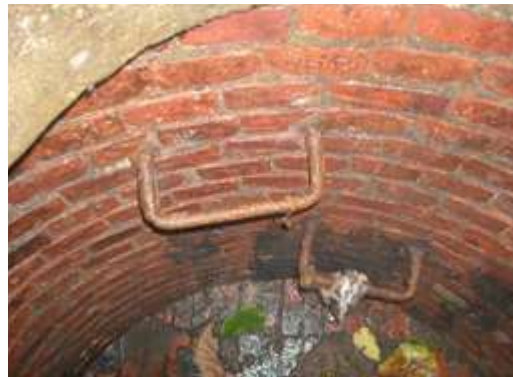
Defect

Infiltration: ☐ None ☒ **Joint** ☐ Cracks ☒ **Mortar** ☒ **Roots** ☐ Wall

Infiltration: ☐ None ☐ Joint ☐ Cracks ☒ **Mortar** ☐ Roots ☒ **Wall**

Corbel and Barrel infiltration.

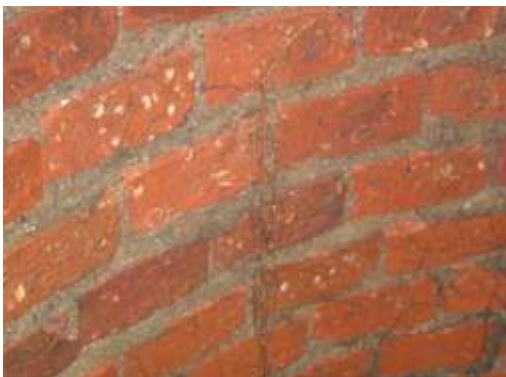
Defect

Condition: ☐ Sound ☐ Cracked ☒ **Root Intrusion** ☐ Loose Brick ☐ Deteriorated

Corbel root intrusion and infiltration.

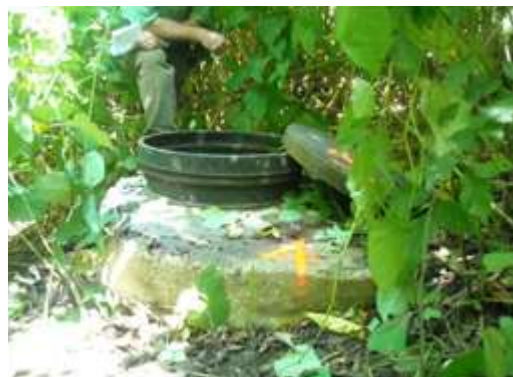
Defect

Above grade.

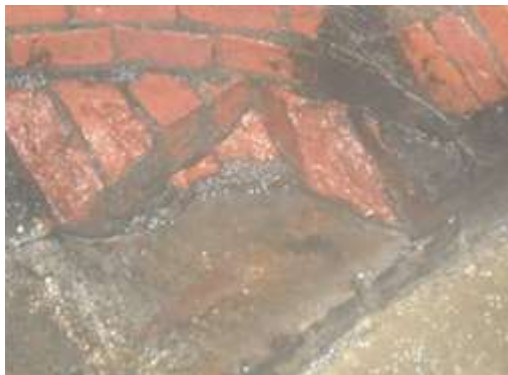
Defect

Condition: ☐ Sound ☐ Cracked ☐ Root Intrusion ☒ **Deteriorated** ☐ Leaks ☐ Debris

Bench deterioration.

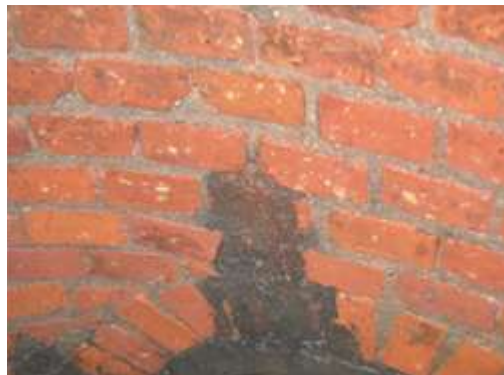
Defect

Barrel infiltration.

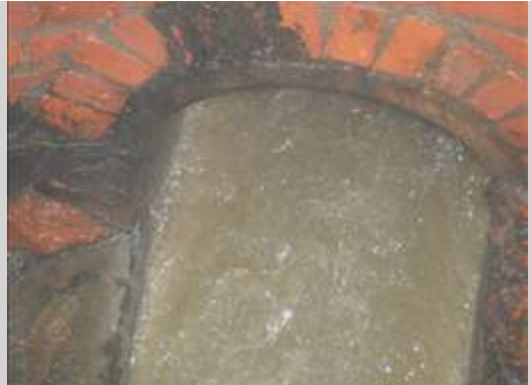
### 21 in. Circular Gravity Sewer Pipe Out @ 12 O'Clock

Infiltration: **Weeper** Pipe Seal Cond: **Unknown**

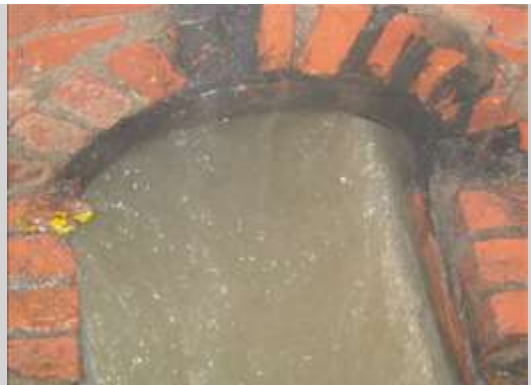
### 15 in. Circular Gravity Sewer Pipe In @ 6 O'Clock

Deposits: ☐ None ☐ Mud ☐ Sludge ☐ Debris ☒ Grease

Silt Depth: **0** (in.) Deposits Extent: **Light**

Infiltration: **Weeper** Pipe Seal Cond: **Unknown**
